DEFENSE CONFERENCE ON NONDESTRUCTIVE TESTING

MINUTES OF THE
15TH ANNUAL MEETING

4, 5, 6, October, 1966

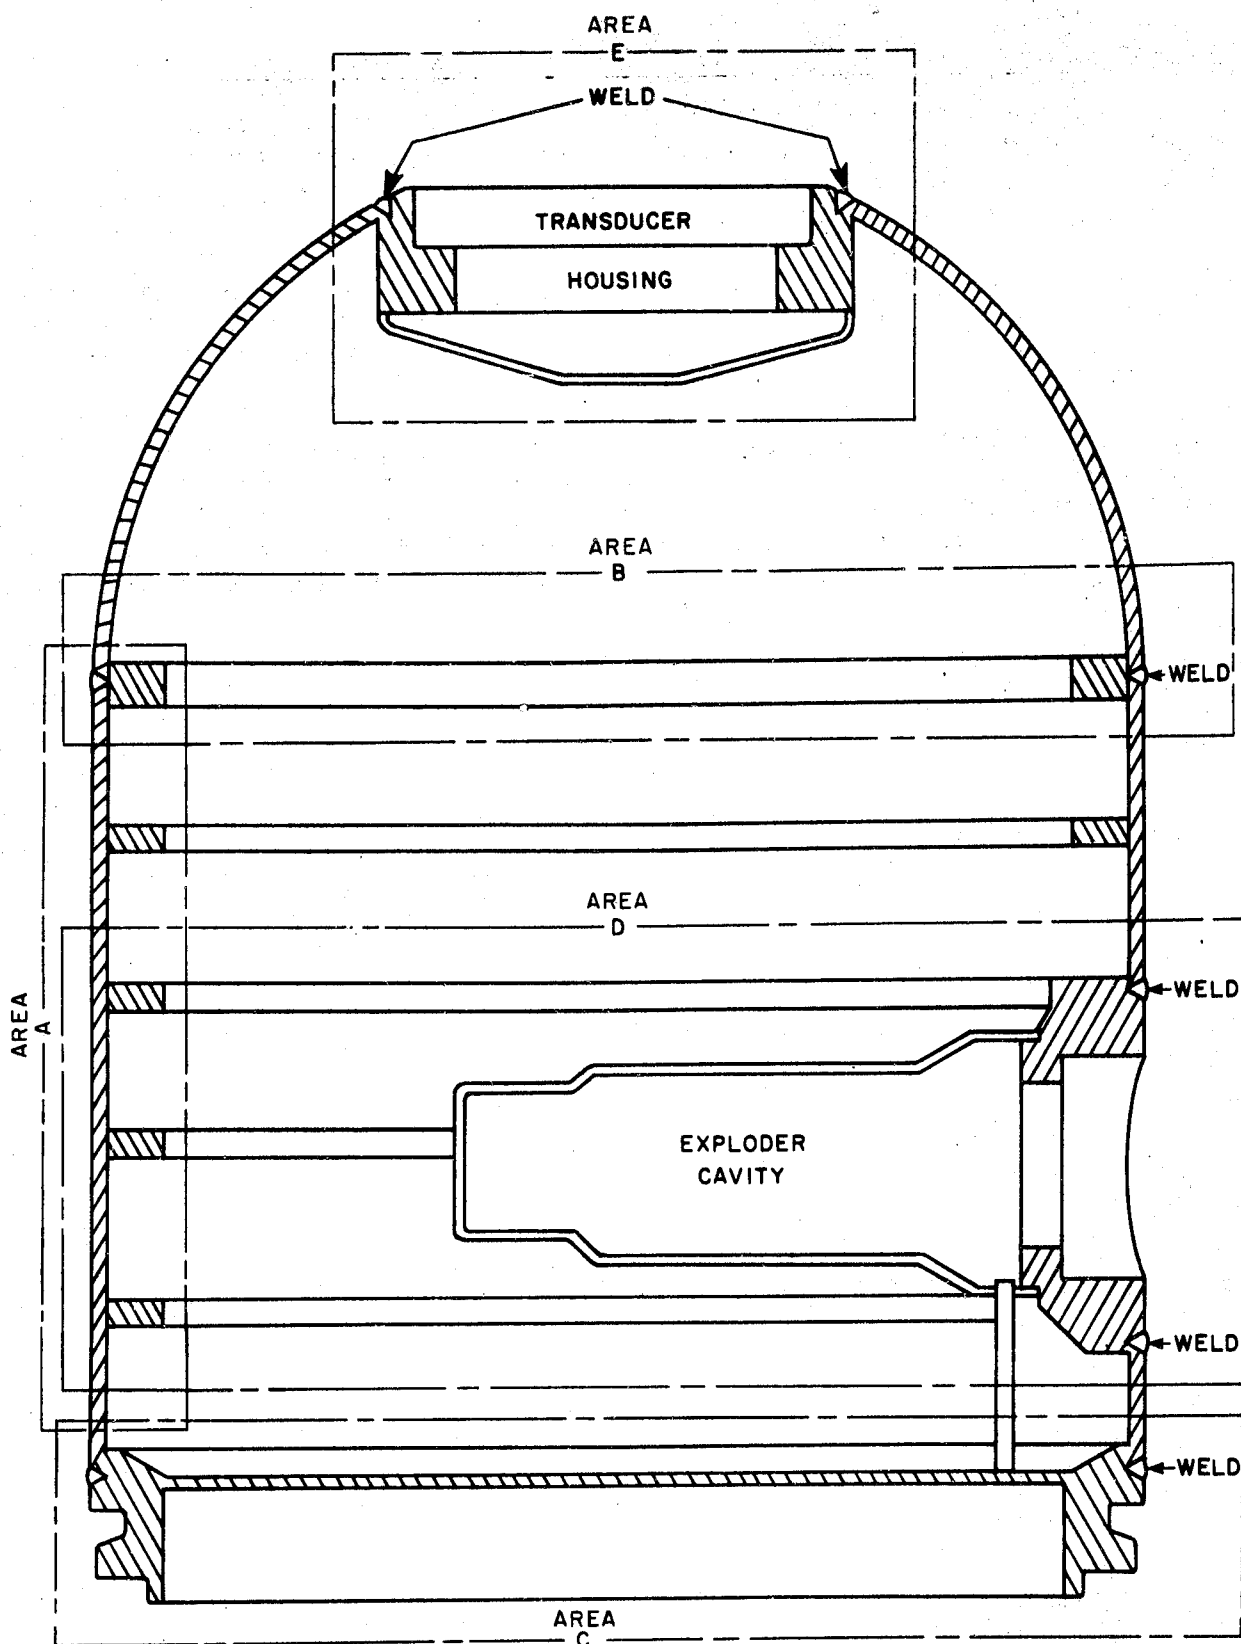
Figure 1. MK 37 Warhead Buord DWG 877240

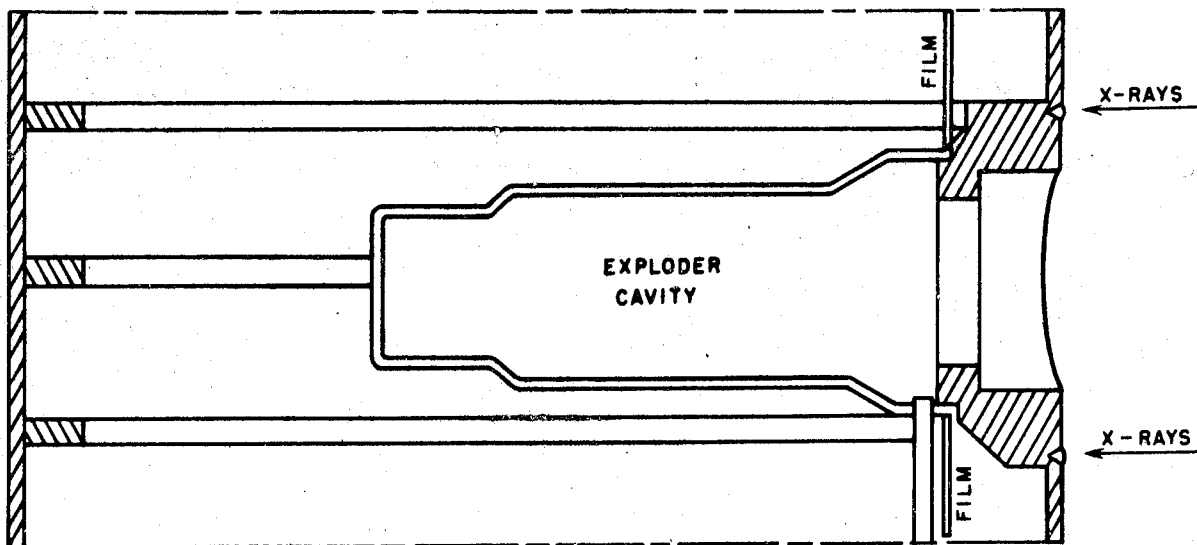
Figure 5. Area D

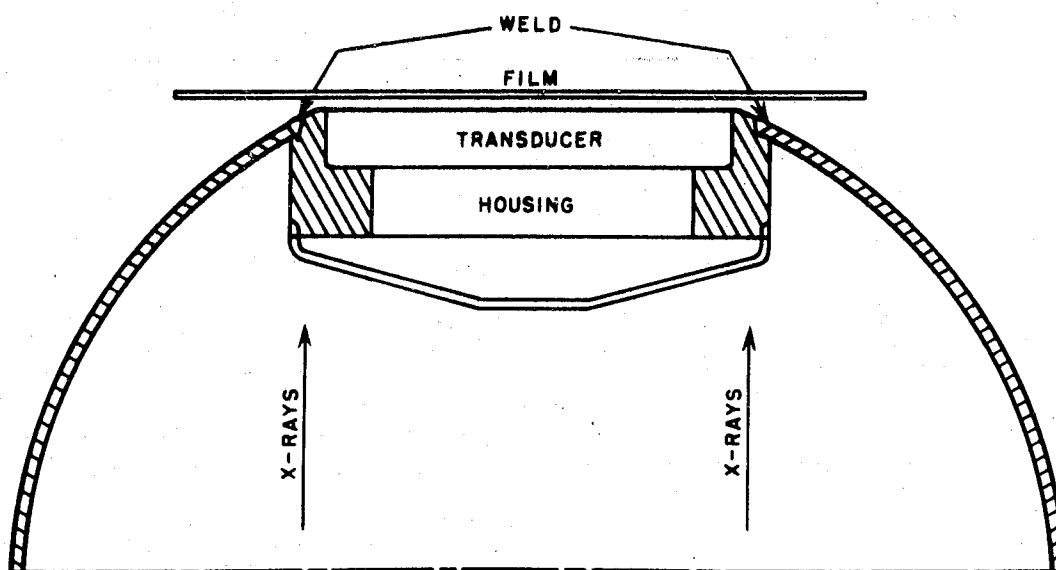
Figure 6. Area E

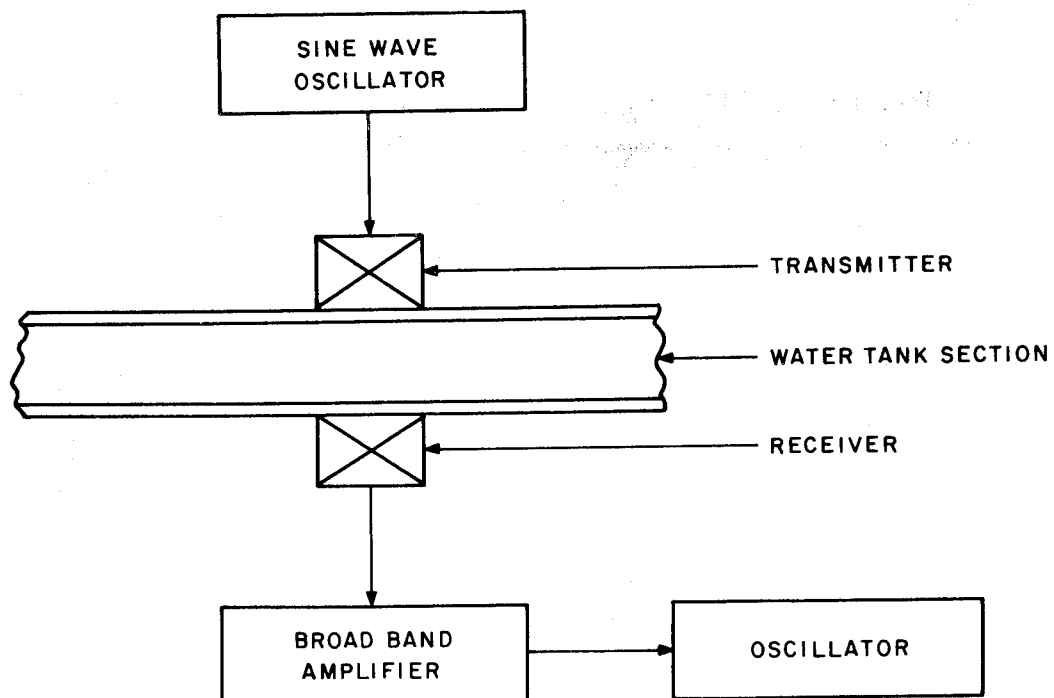
Figure 12. Test, Block Diagram

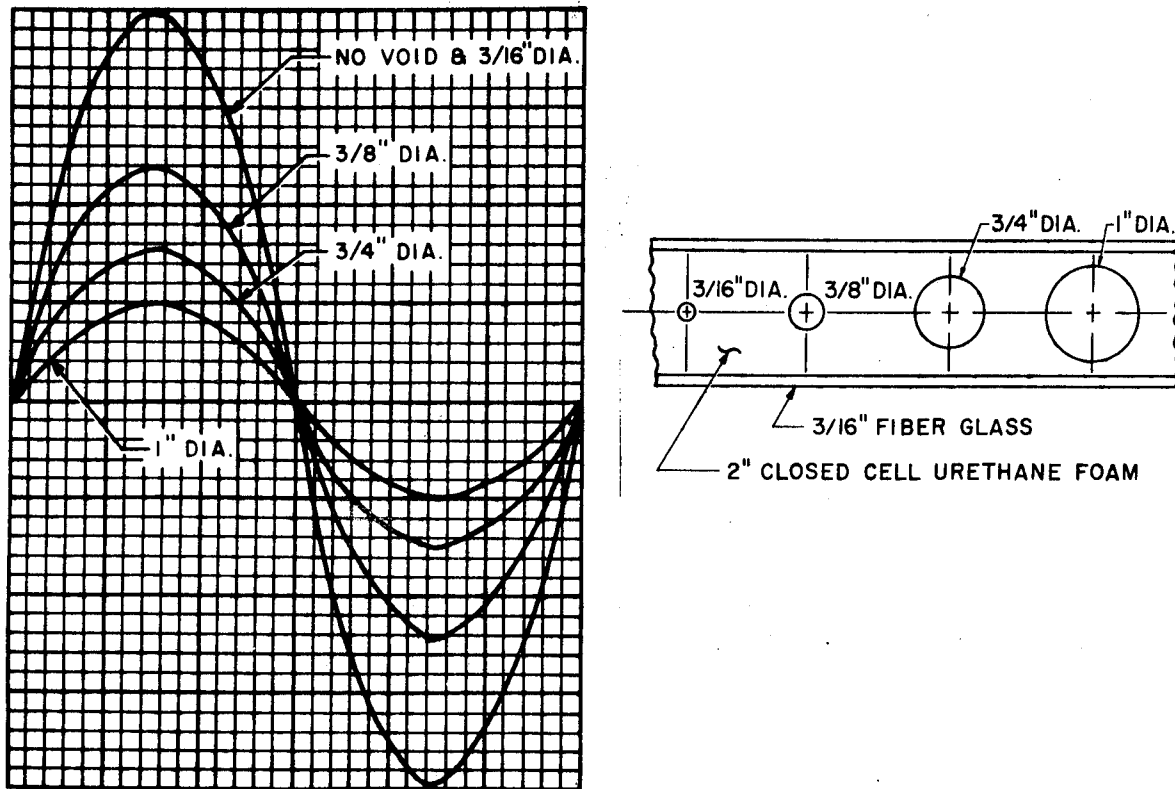
Figure 13. Attenuation Vs. Void Size

Figure 13 shows the location and size of various diameter holes in the urethane foam and the signal attenuation caused by these holes. From this

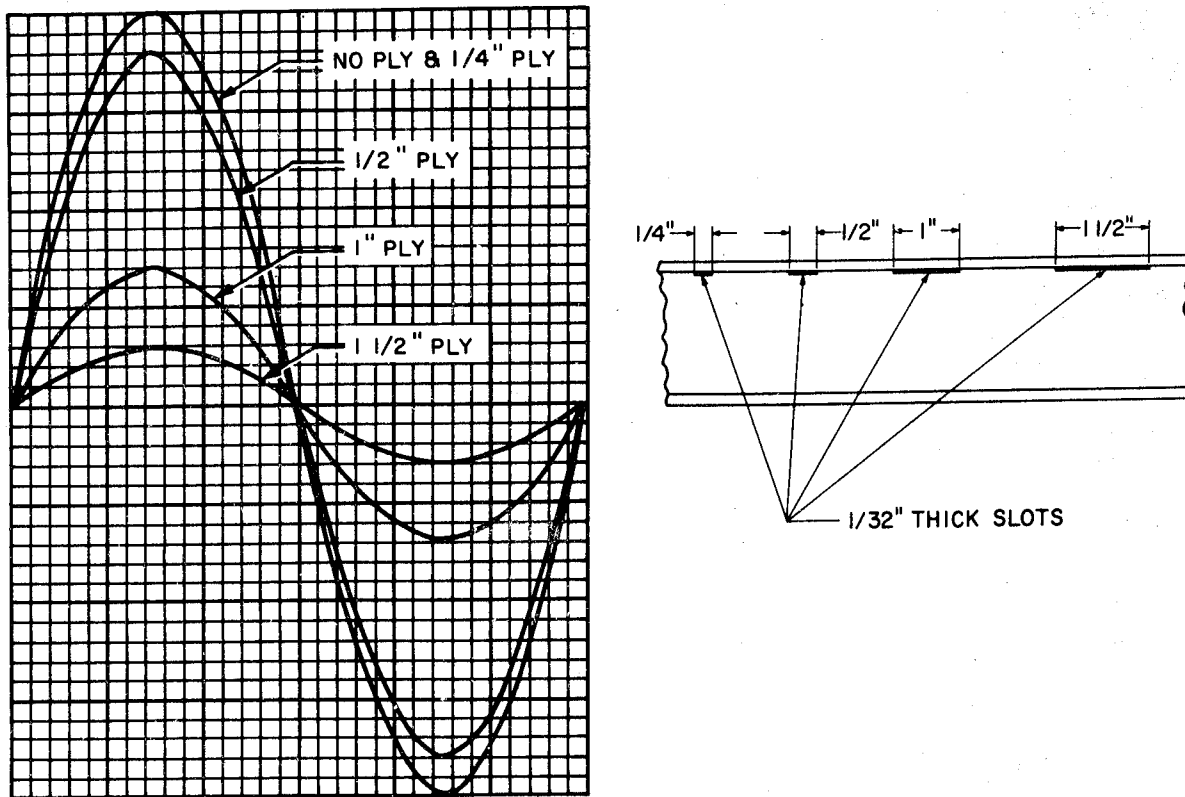
Figure 15. Attenuation Vs. Ply Separation Size

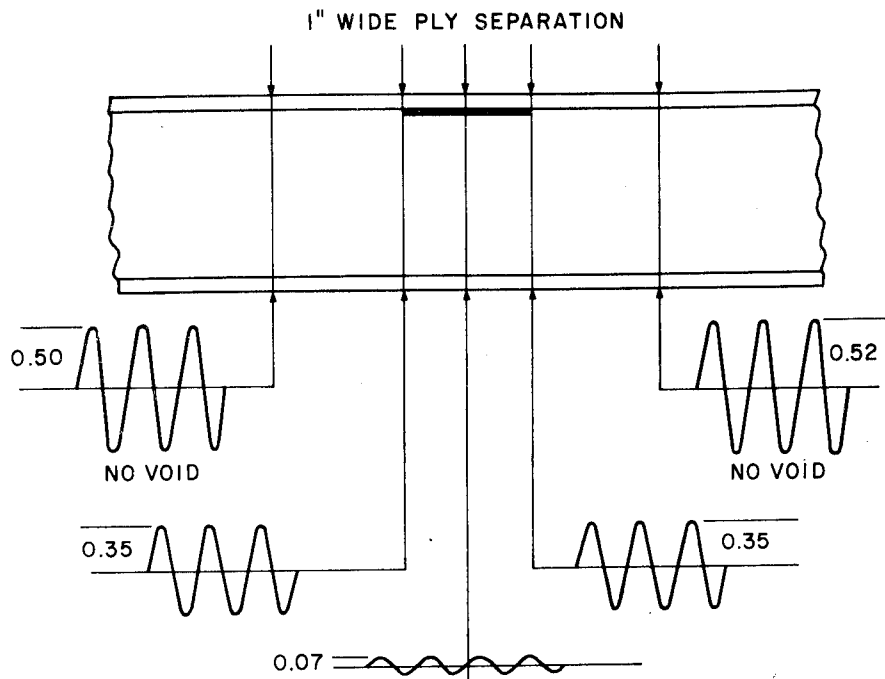
Figure 16. Attenuation Vs. Position of Transducer over 1" Wide Ply Separation

Figure 16 shows the effect of attenuation versus transducer location relative to the centerline of a 1 inch ply separation. Due to the closeness of the transducer to the defect the relative location of the transducer greatly effects attenuation.

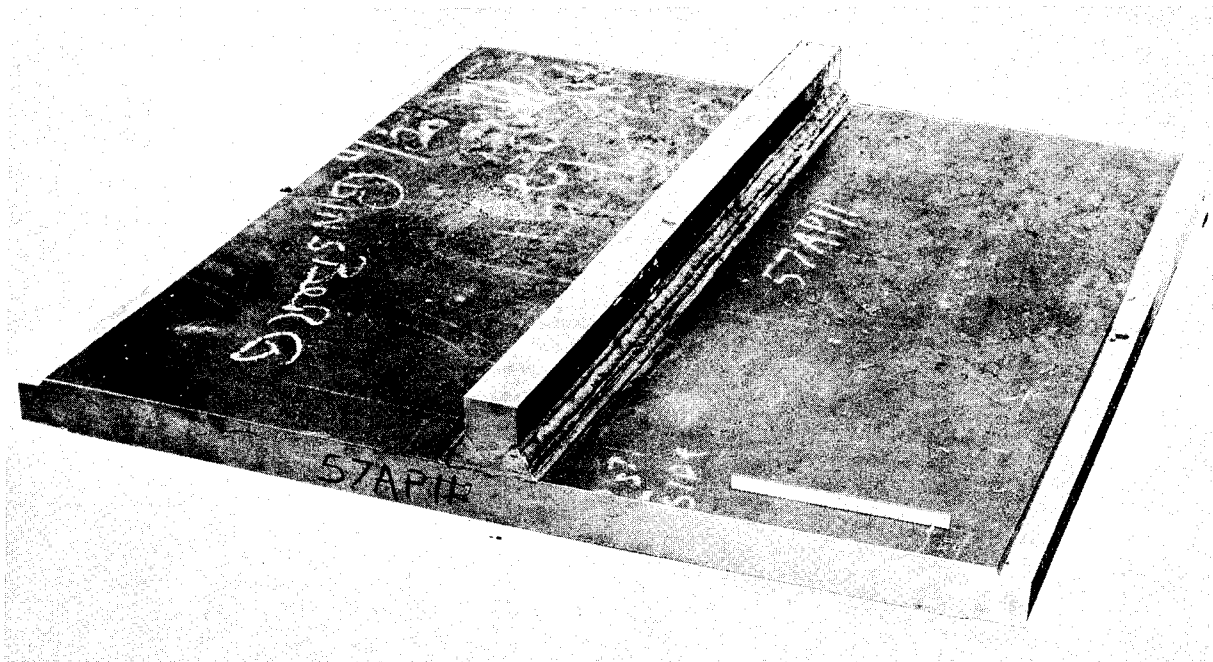
Figure 1. Tee-Welded Fatigue Specimen

The tee-welded plate fatigue specimen is shown in Figure 1. The test must be carried out without removing the specimen from the machine in which it is subjected to the cyclic loading. Figure 2a is an overall view of the experimental setup. The ultrasonic probe must be manipulated within the limitations imposed by the heavy grid structure of the holding down fixture which is over the specimen proper. A closeup of the specimen within the fatigue machine is shown in Figure 2b. Figure 3 shows a butt-weld plate specimen which is being developed for exploratory crack growth studies for high strength steels. The appearance of the crack at about 4X, on the rough polished specimen edge, is shown in the enlarged portion of Figure 3.

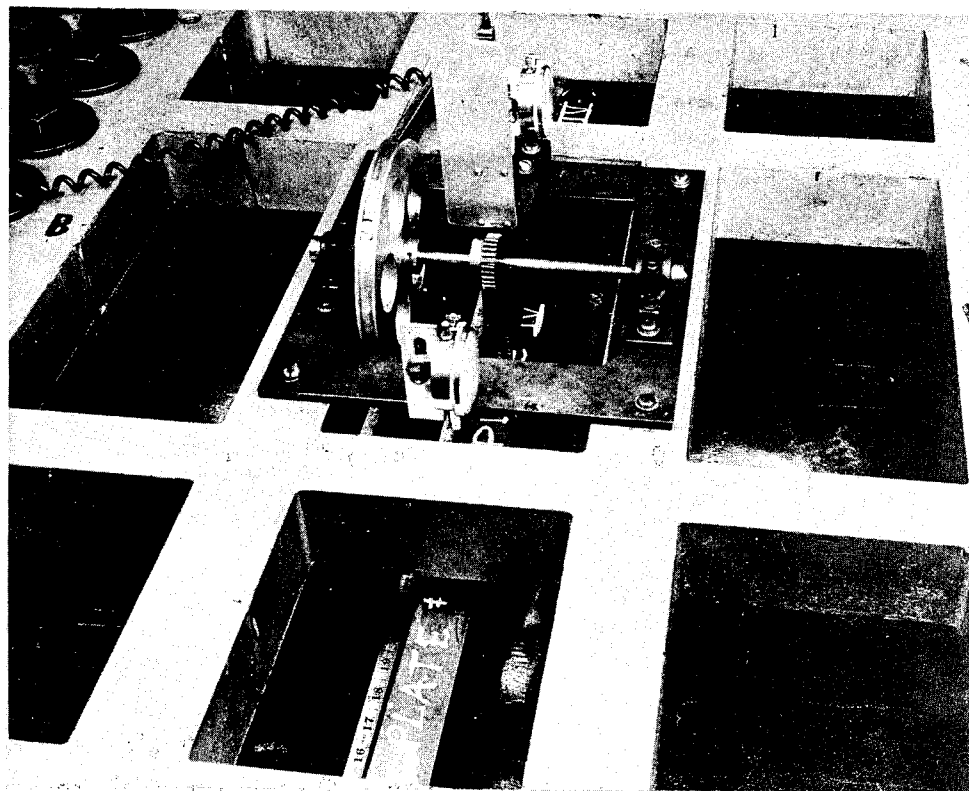
b. CLOSEUP OF T-WELD SPECIMEN

Figure 2. Fatigue Test Setup

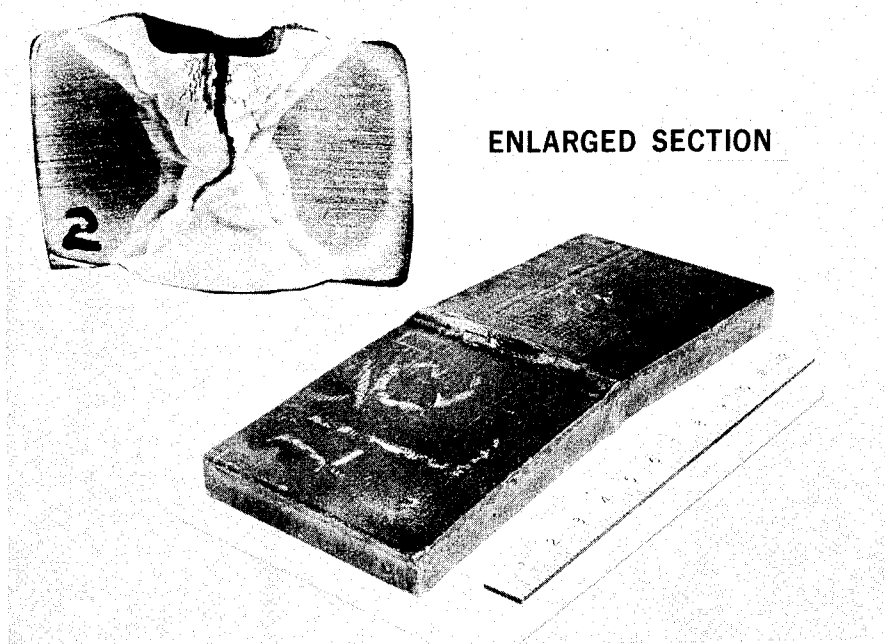
Figure 3. Butt-Weld Specimen for Estimation of Notch-Toughness Overall View and Enlarged View of Section Including Crack

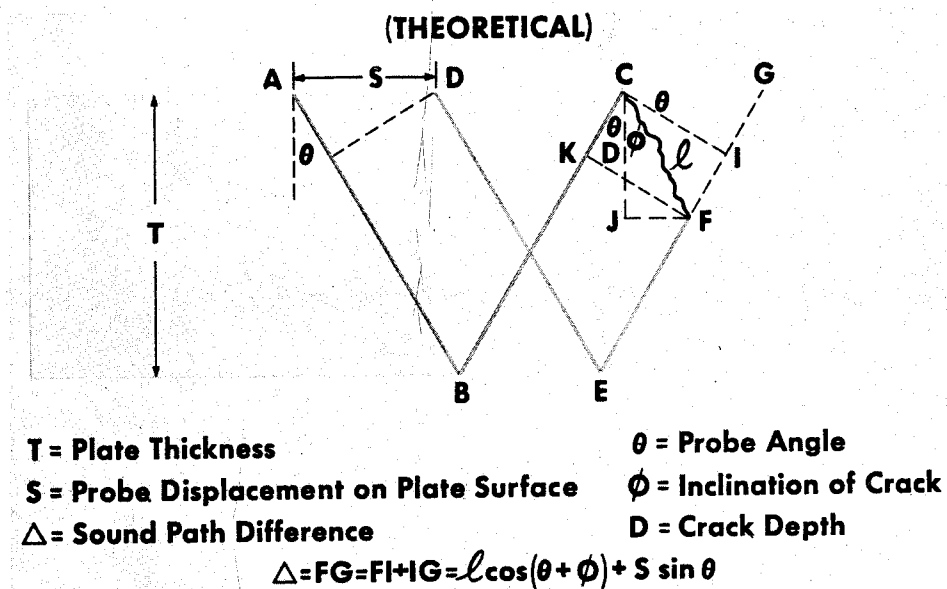
Figure 4. "Back-Reflection" Method

Analytical expressions for the inclination and depth of the crack for the tee-welded specimen were first derived by the use of a "back-reflection" method and on the simplifying assumption that the ultrasonic beam has no width. Figure 4 shows a sketch used to make the analysis. The vertical component of the crack depth, d , and its inclination to the vertical, \emptyset , are functions of two items which are measureable. These are:

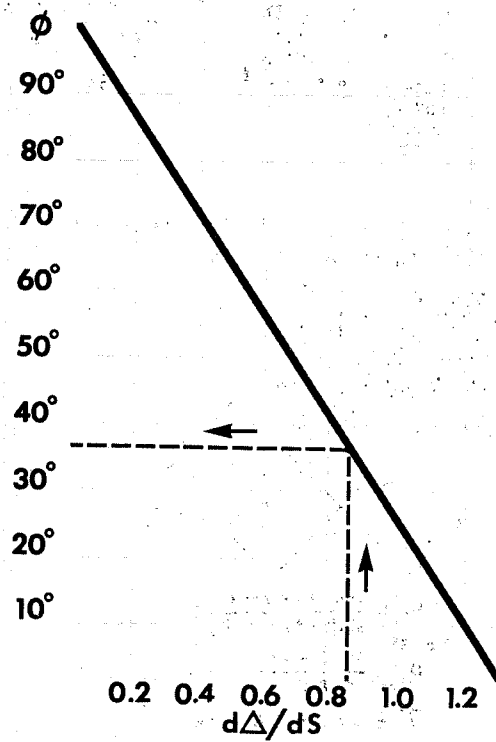
Figure 6. Crack Inclination (ϕ) vs. $d\Delta/dS$

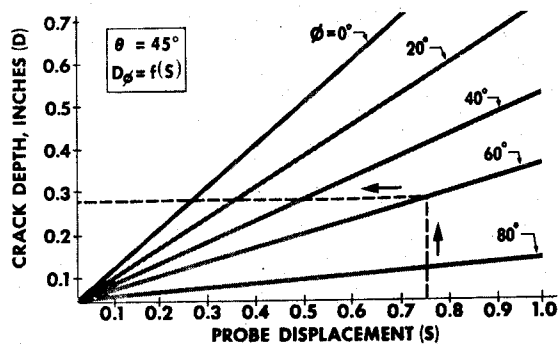
Figure 7. Crack Depth, d , vs. Probe Motion, S .

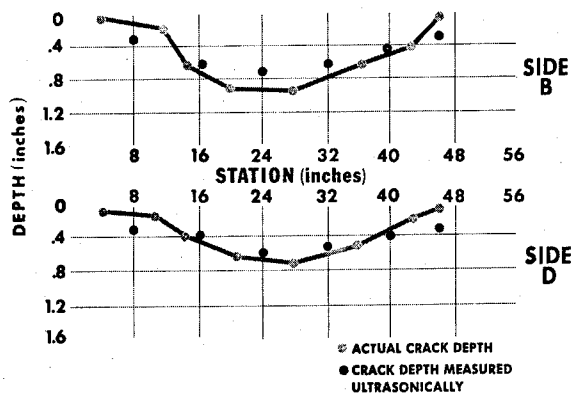
Figure 8. Initial Results for Tee-Welded Fatigue Specimen. Crack Depth for Various Stations, Actual vs. Ultrasonically determined

Figure 8 summarizes initial results obtained by the approach just described. It will be noted that the agreement for depths of about 1/2 in. and over is fair to good, based on visual observation of cracks at corresponding sections of the weldment. On the other hand for shallower depths the agreement between ultrasonically determined values and actual ones is poor and the former are consistently an overestimate. This difference can be explained by the fact that in actual practice the beam width is not zero.

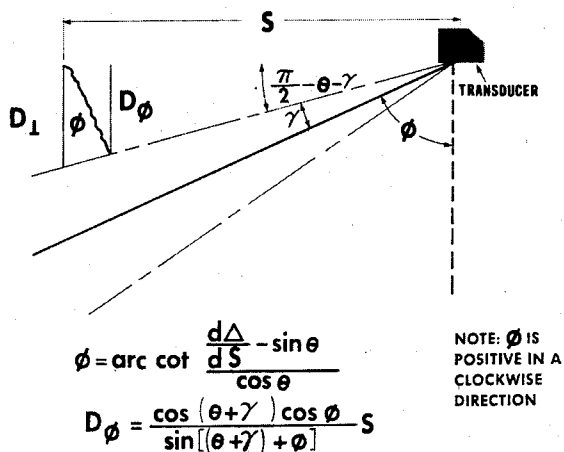
Figure 9. "Direct" Reflection Method

Figure 9 shows the transducer in position for which the extreme ray of the sound beam, having a finite angular width, just reflects from the bottom of the crack. The inclination of the crack can be determined from the equation

Now, if as in Figure 9, d_ϕ = vertical depth of the crack, and γ = half angular beam width, it can be shown that:

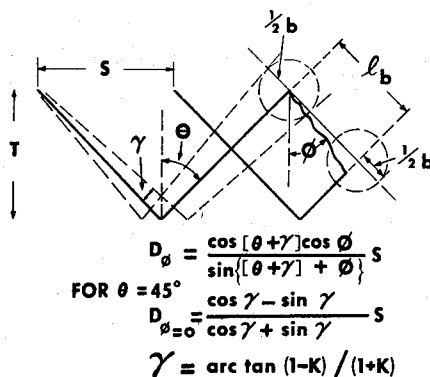
Figure 11. Effect of Beam Width on Crack Depth Estimation

Beam Width and Accuracy of Crack-Depth Estimate - In Figure 11, let l_b = expected length of crack in plane normal to the beam direction; then

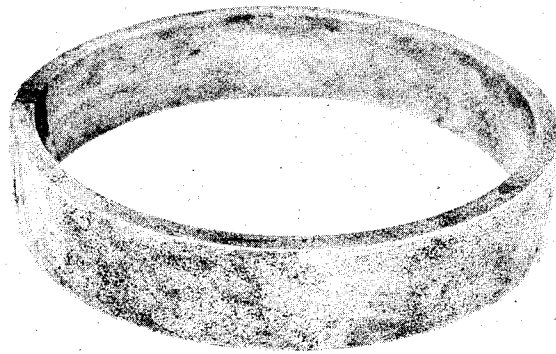
Figure 1. Photograph of Rotating Band Blank 9/16X

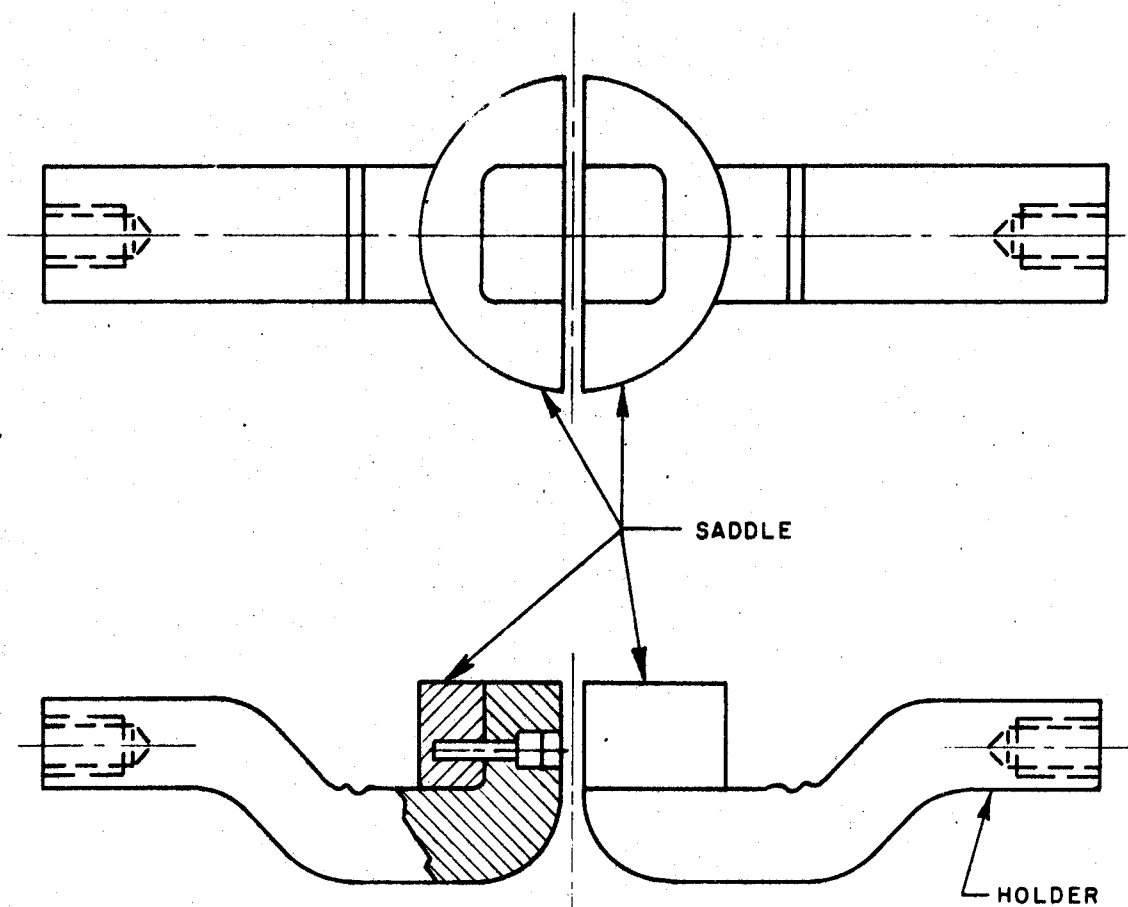
DIAMETER OF THE SADDLE = MINIMUM DIAMETER OF THE ROTATING BAND
BLANK MINUS 0.020 INCHES MINUS 0.010 INCHES (MACHINE TOLERANCE)

Figure 3. Tensile Test Fixture Assembly for Rotating Bands

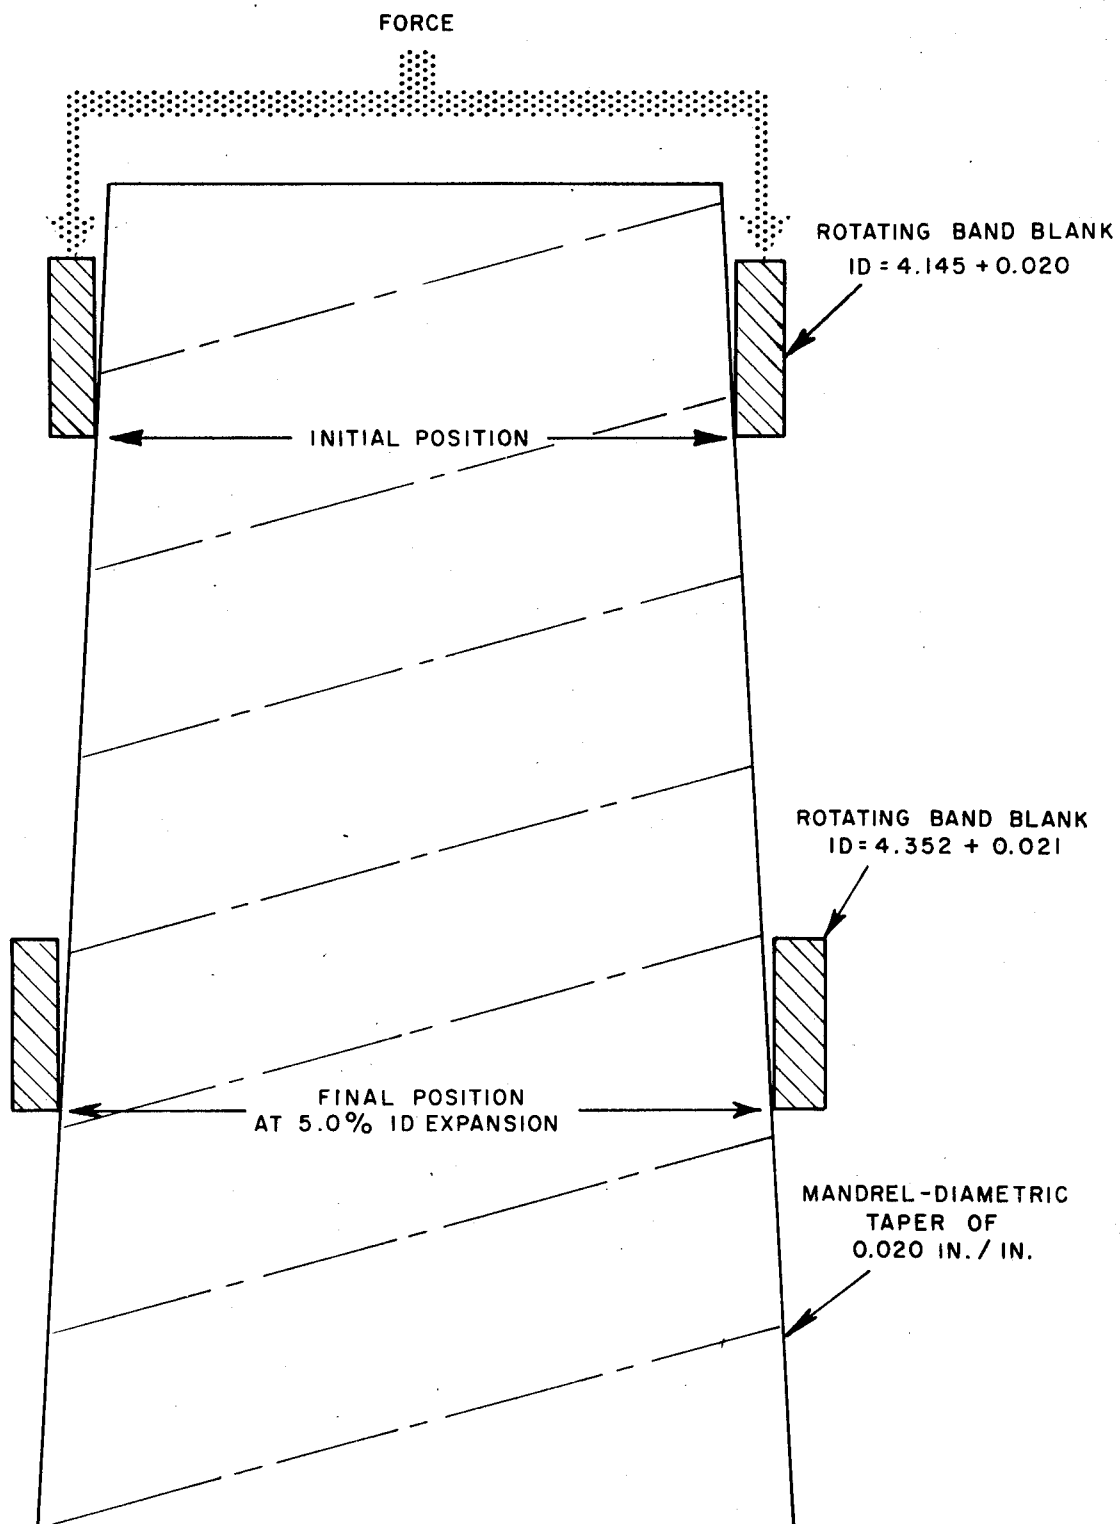
Figure 4. Ductility Test Fixture

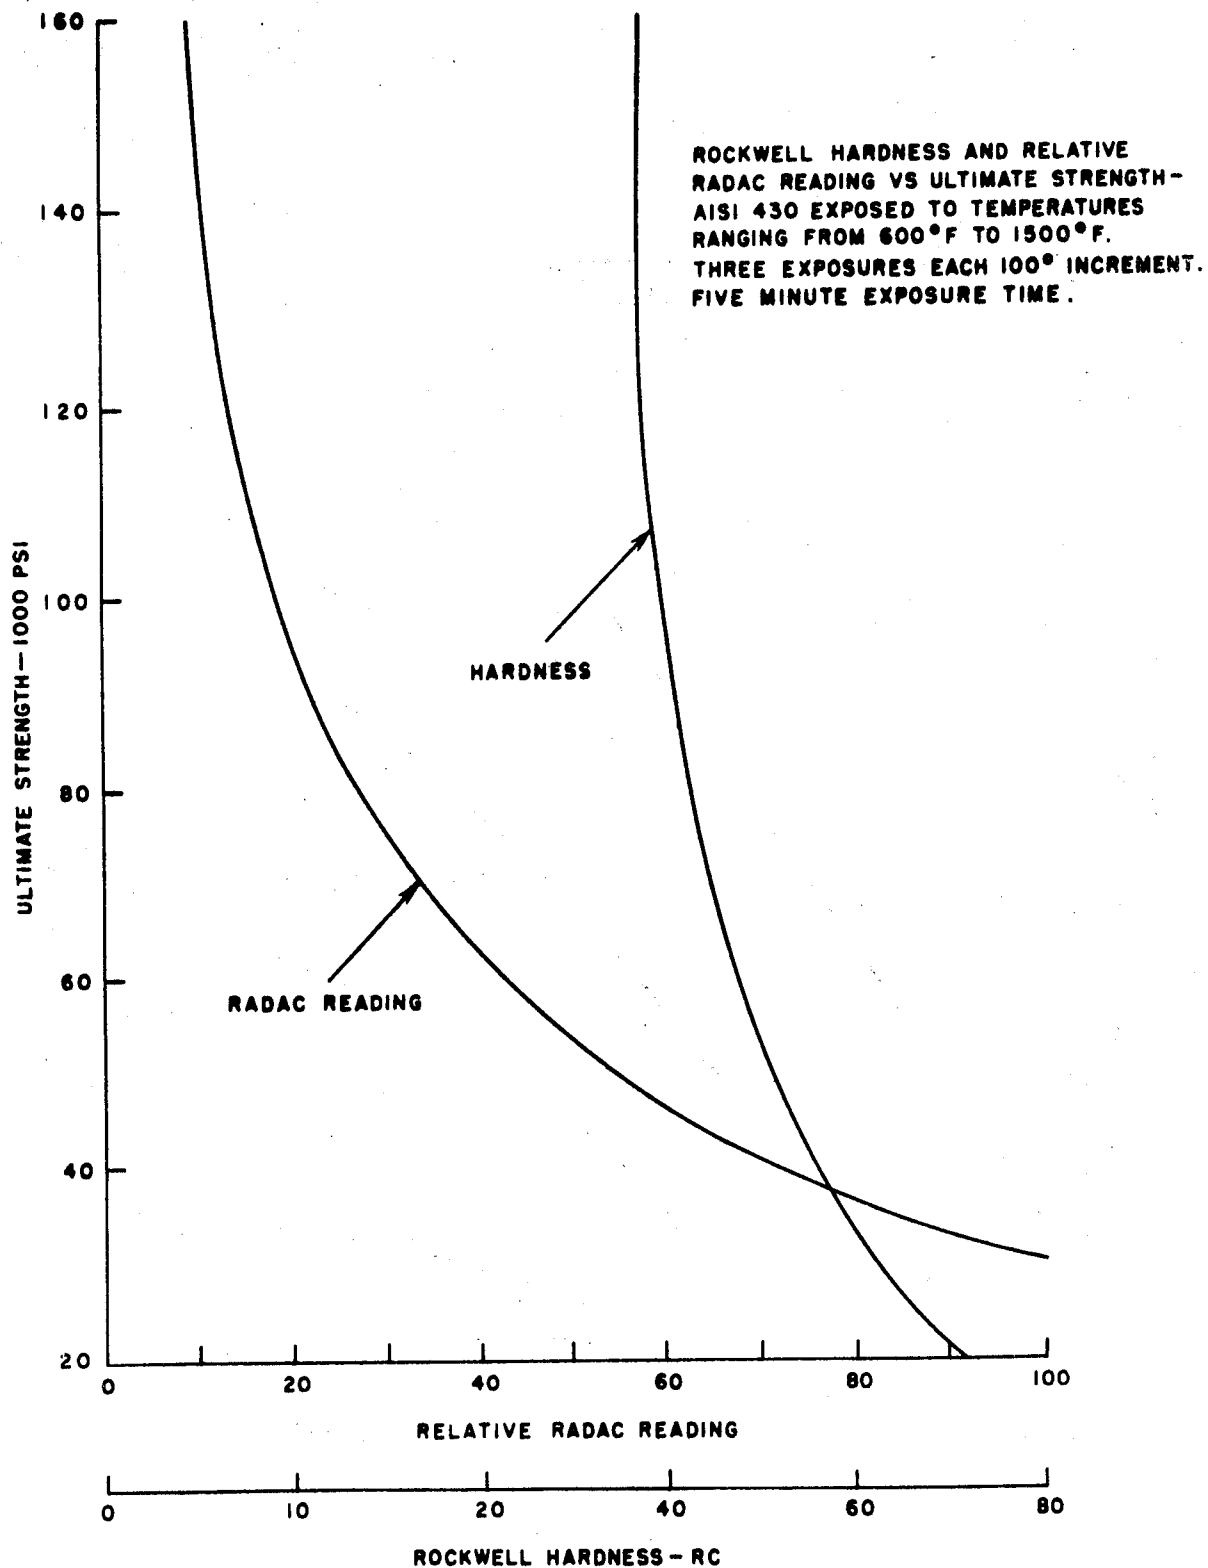
Figure 1. Rockwell Hardness and Relative Radac Reading vs Ultimate Strength

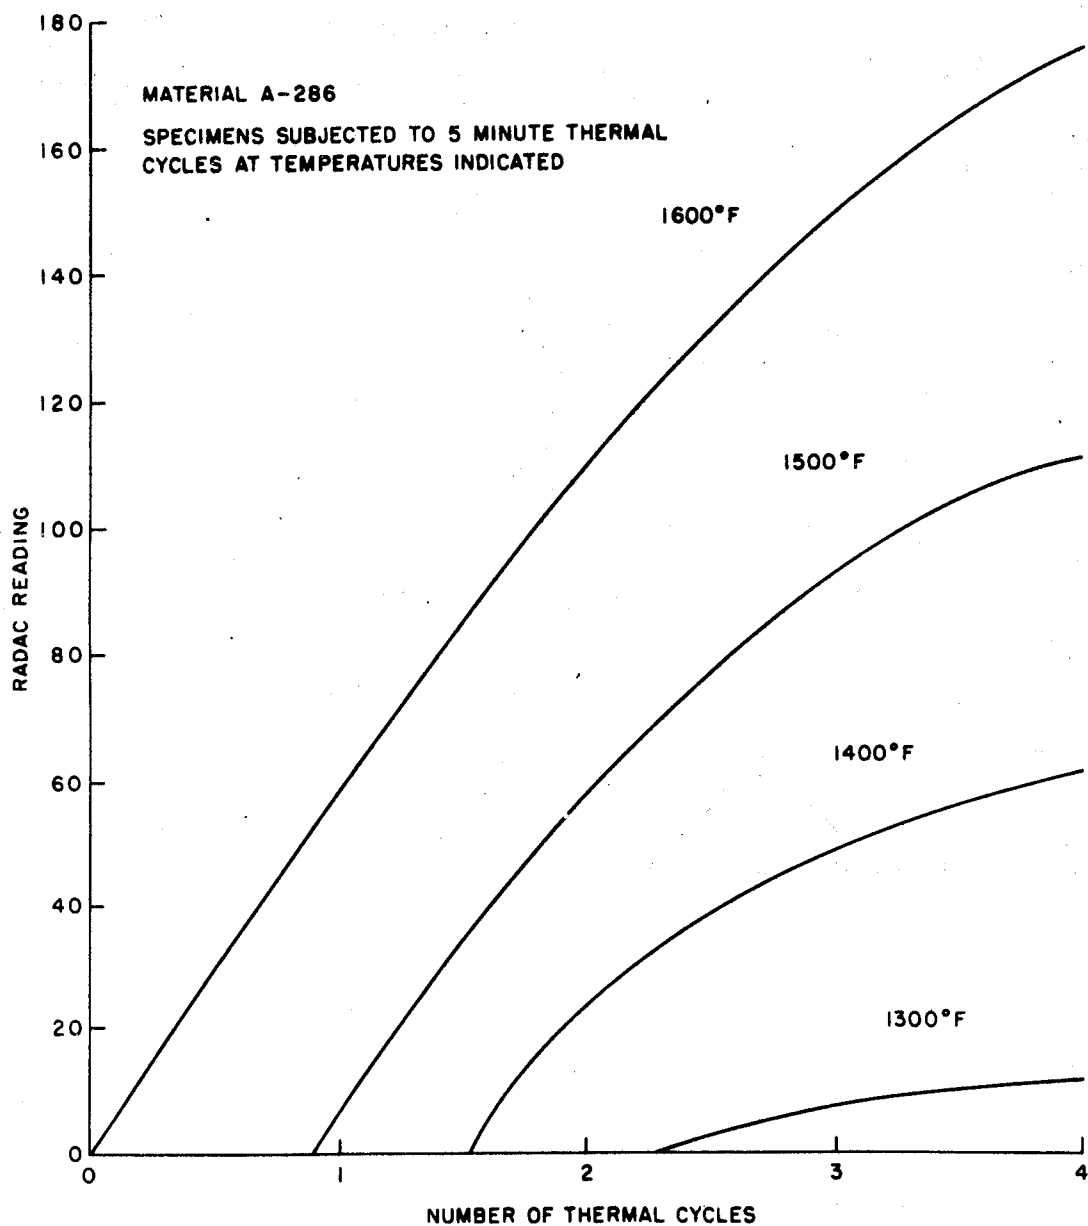
Figure 2. Number of Thermal Cycles vs Relative Radac Reading

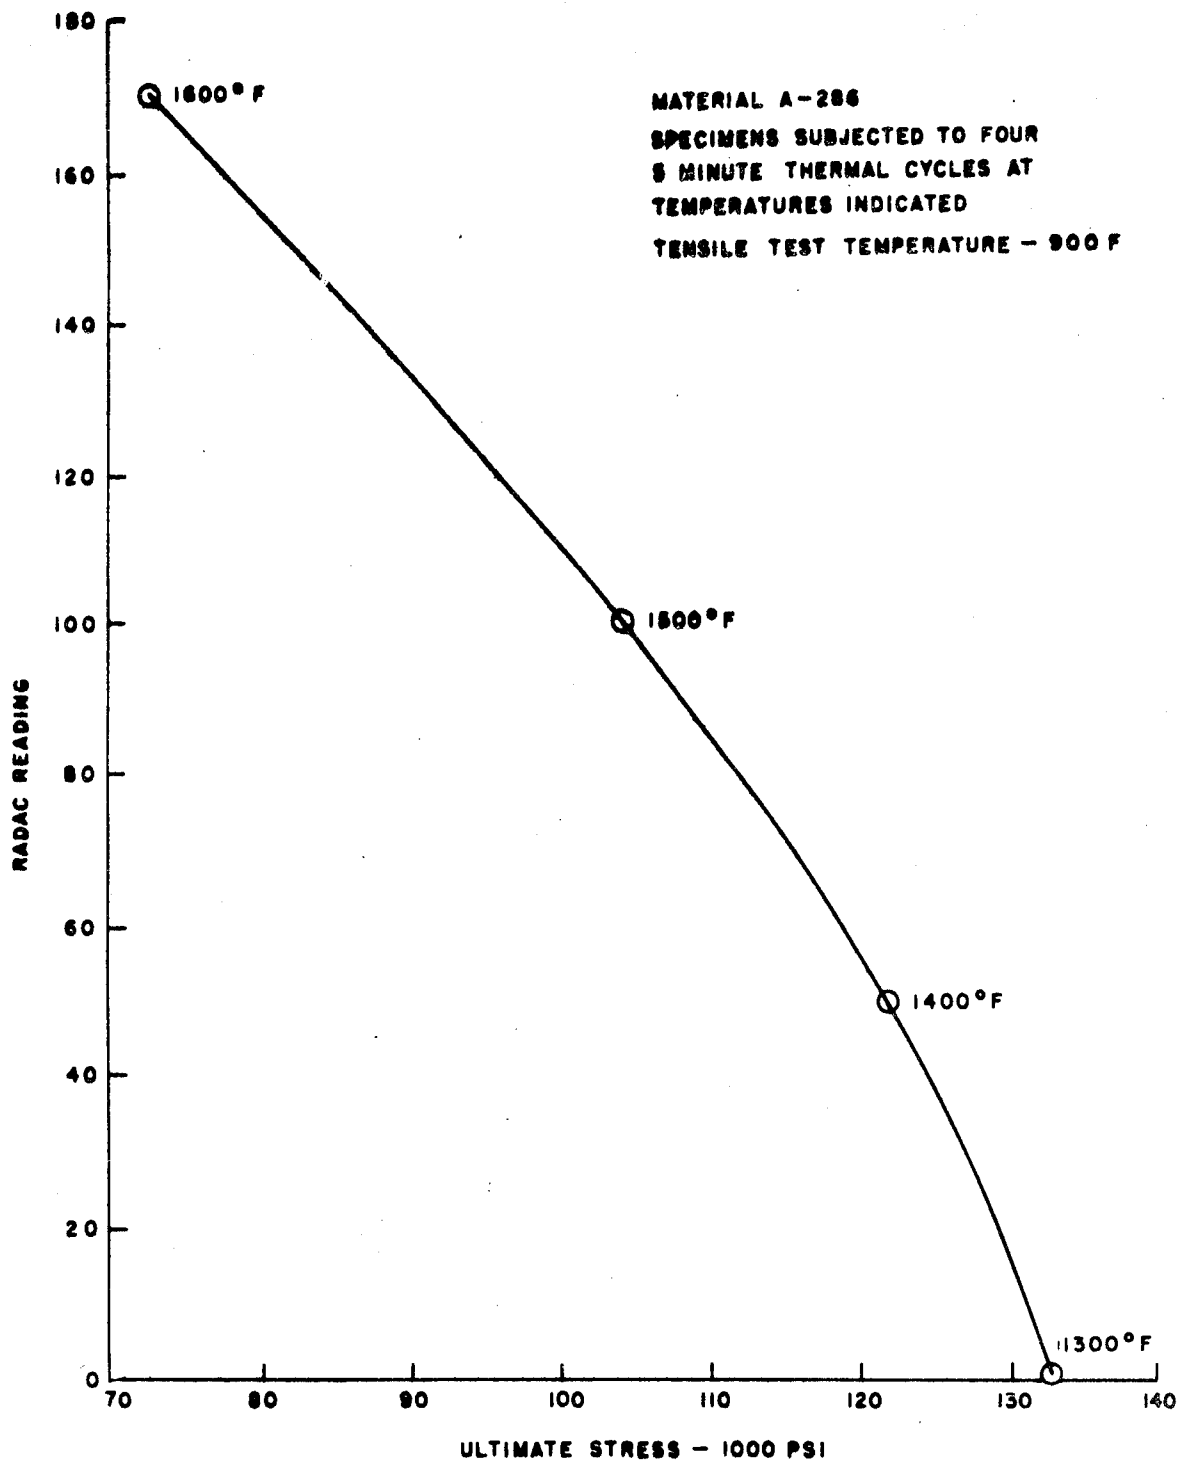
Figure 3. Radac Reading vs Ultimate Stress

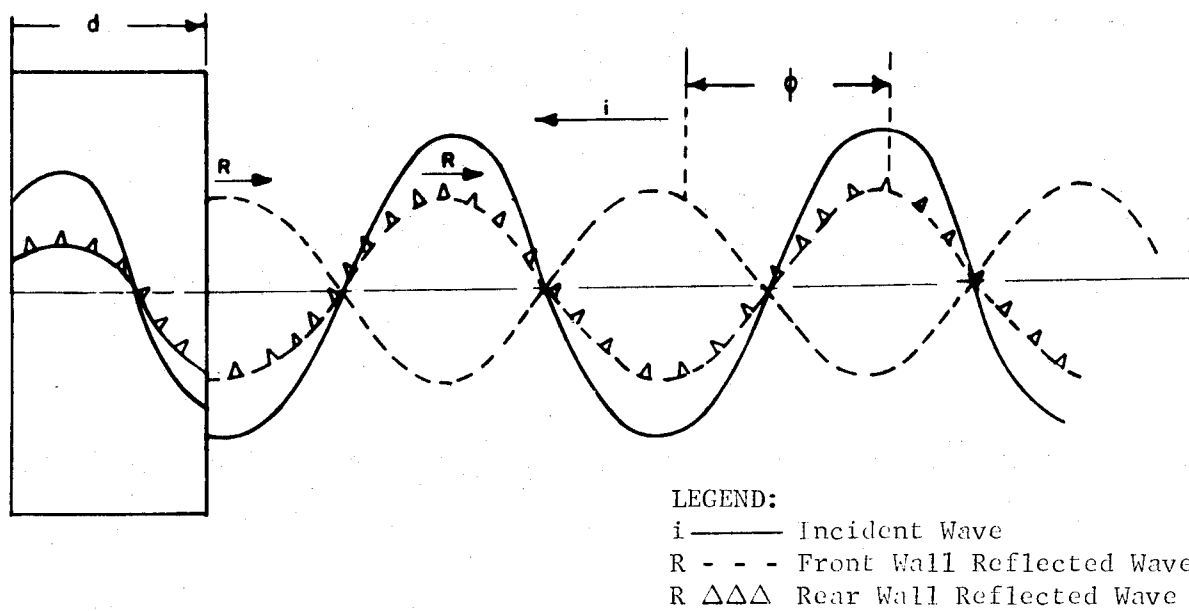
Figure 2. Standing Wave in Front of a Plane Dielectric Sheet

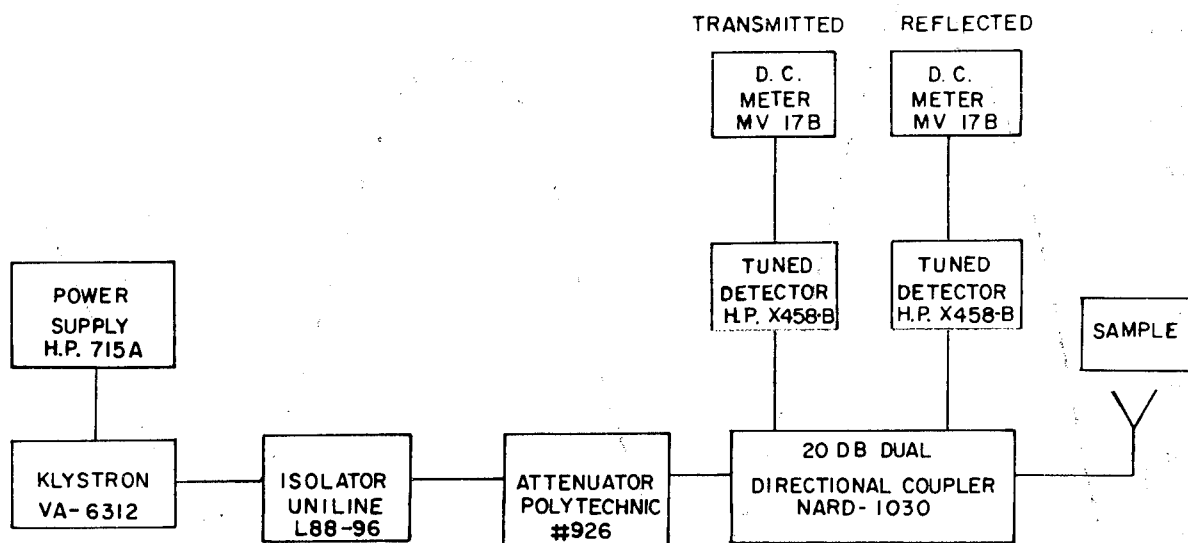
Figure 3. Reflection Method

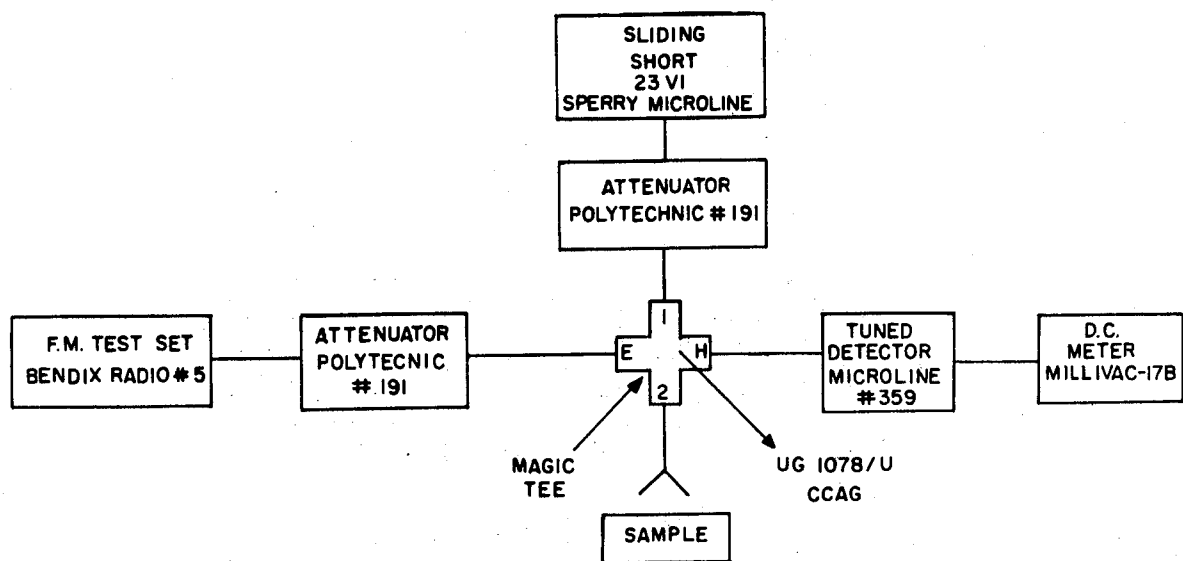
Figure 10. Magic Tee Reflection Method

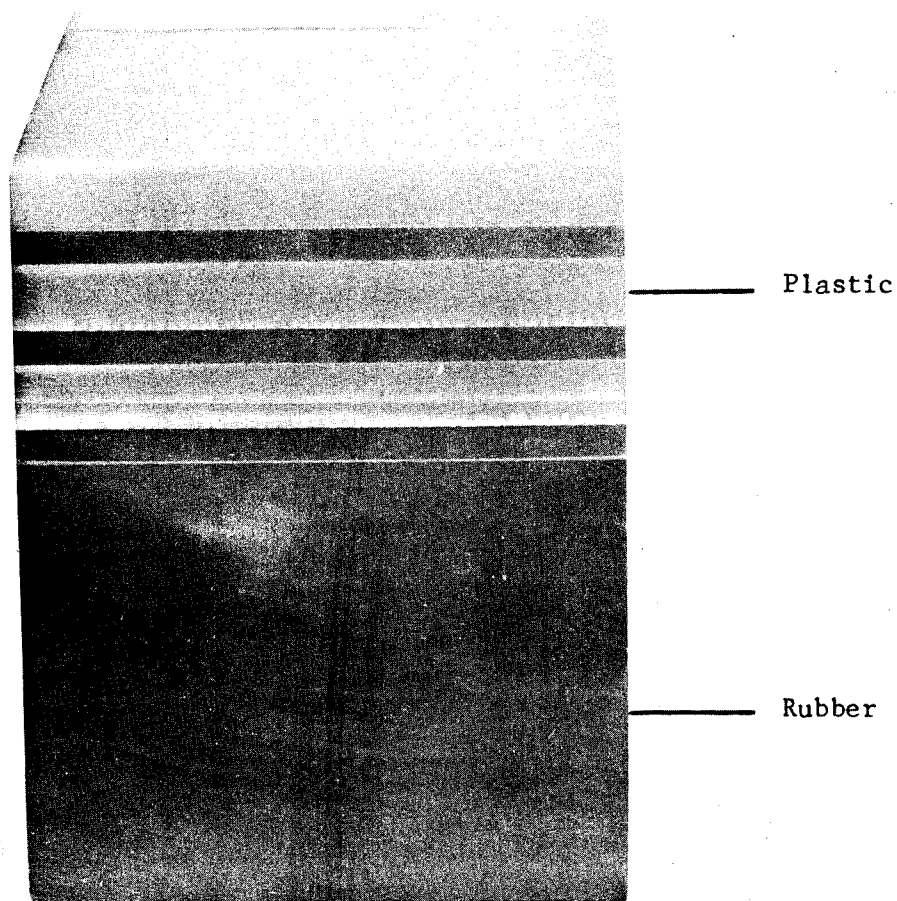
Figure 11. Filament-Wound Plastic with Rubber Liner

(Microwave reflection methods have been shown to be useful in detecting lack of bond between filament-wound reinforced plastic and rubber liner. The lack of bond varied from .05 to 1 inch in diameter.
